MTS DP Committee

Workshop in Singapore 2018

Unwanted Thrust

Drive Off on Diving Vessel

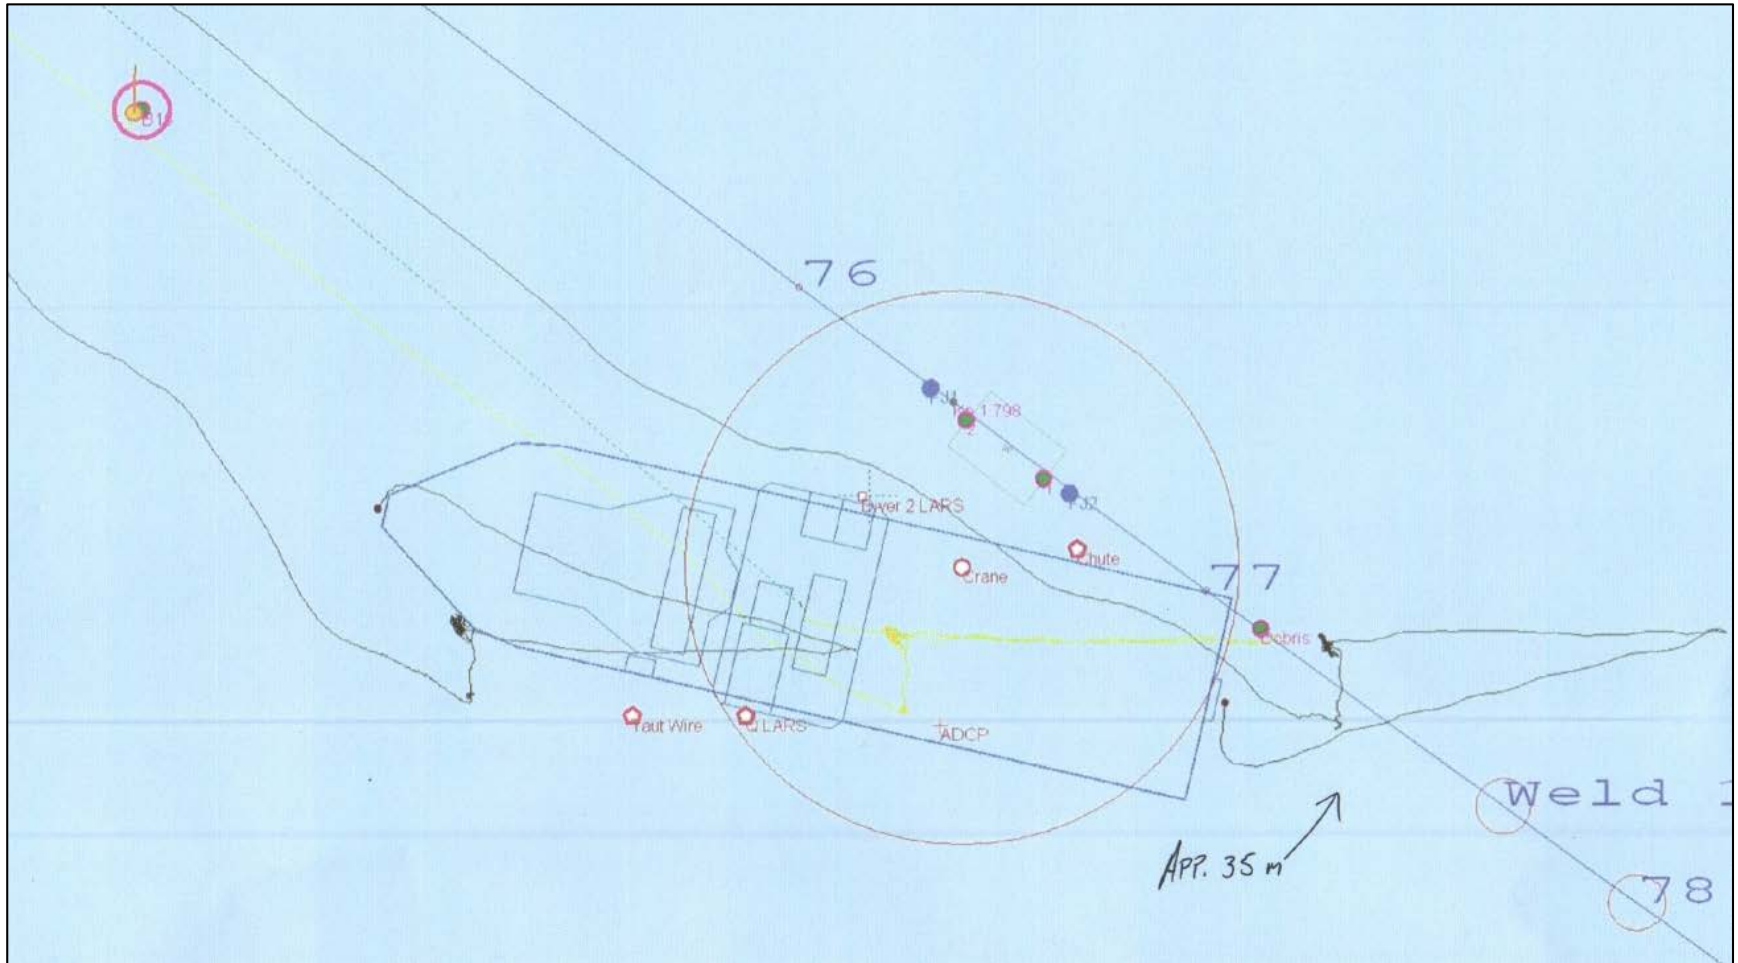
Safety Alert

- High potential incident on diving vessel
- No consequences by chance only

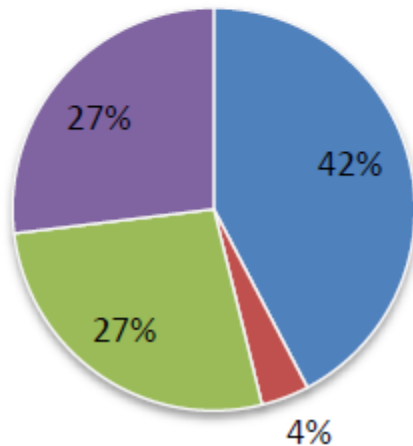
Results Breakdown

Causal and contributory factors

Design	11
Operations	1
People	7
Process	7
